SKYLAB ATM

CALIBRATION ROCKET PROJECT

FINAL REPORT

April 30, 1974

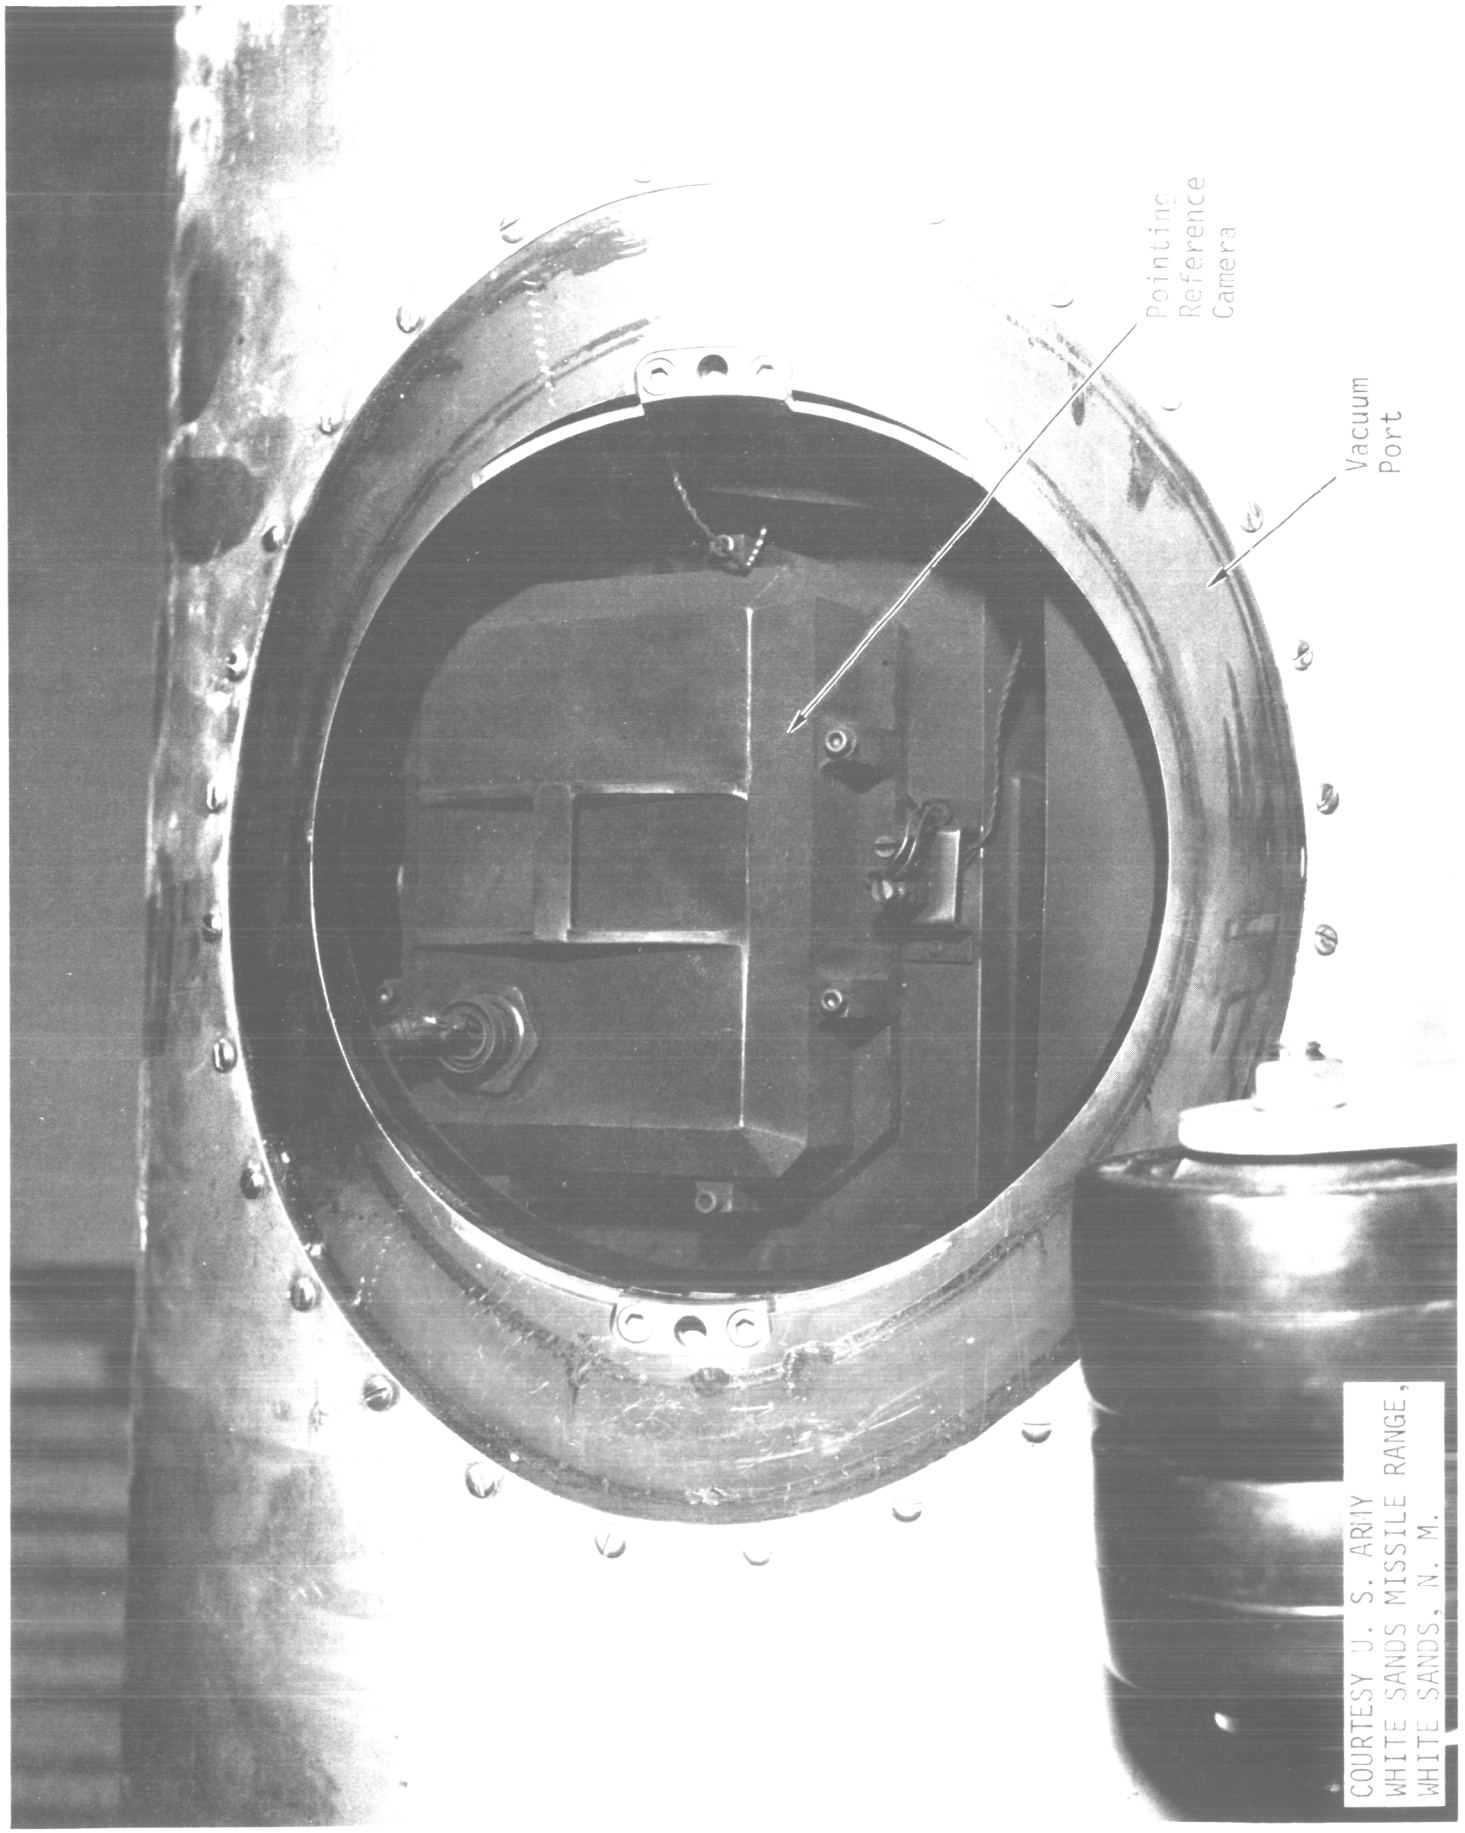
Some of the payload damage resulting from thrust termination can be seen in Figures 6-1, 6-2, and 6-3. The degree of subnominal

Figure 6-3. Post-Flight HCO CALROC 21.021 Payload, Carbon Deposit Seen thru Vacuum Door.

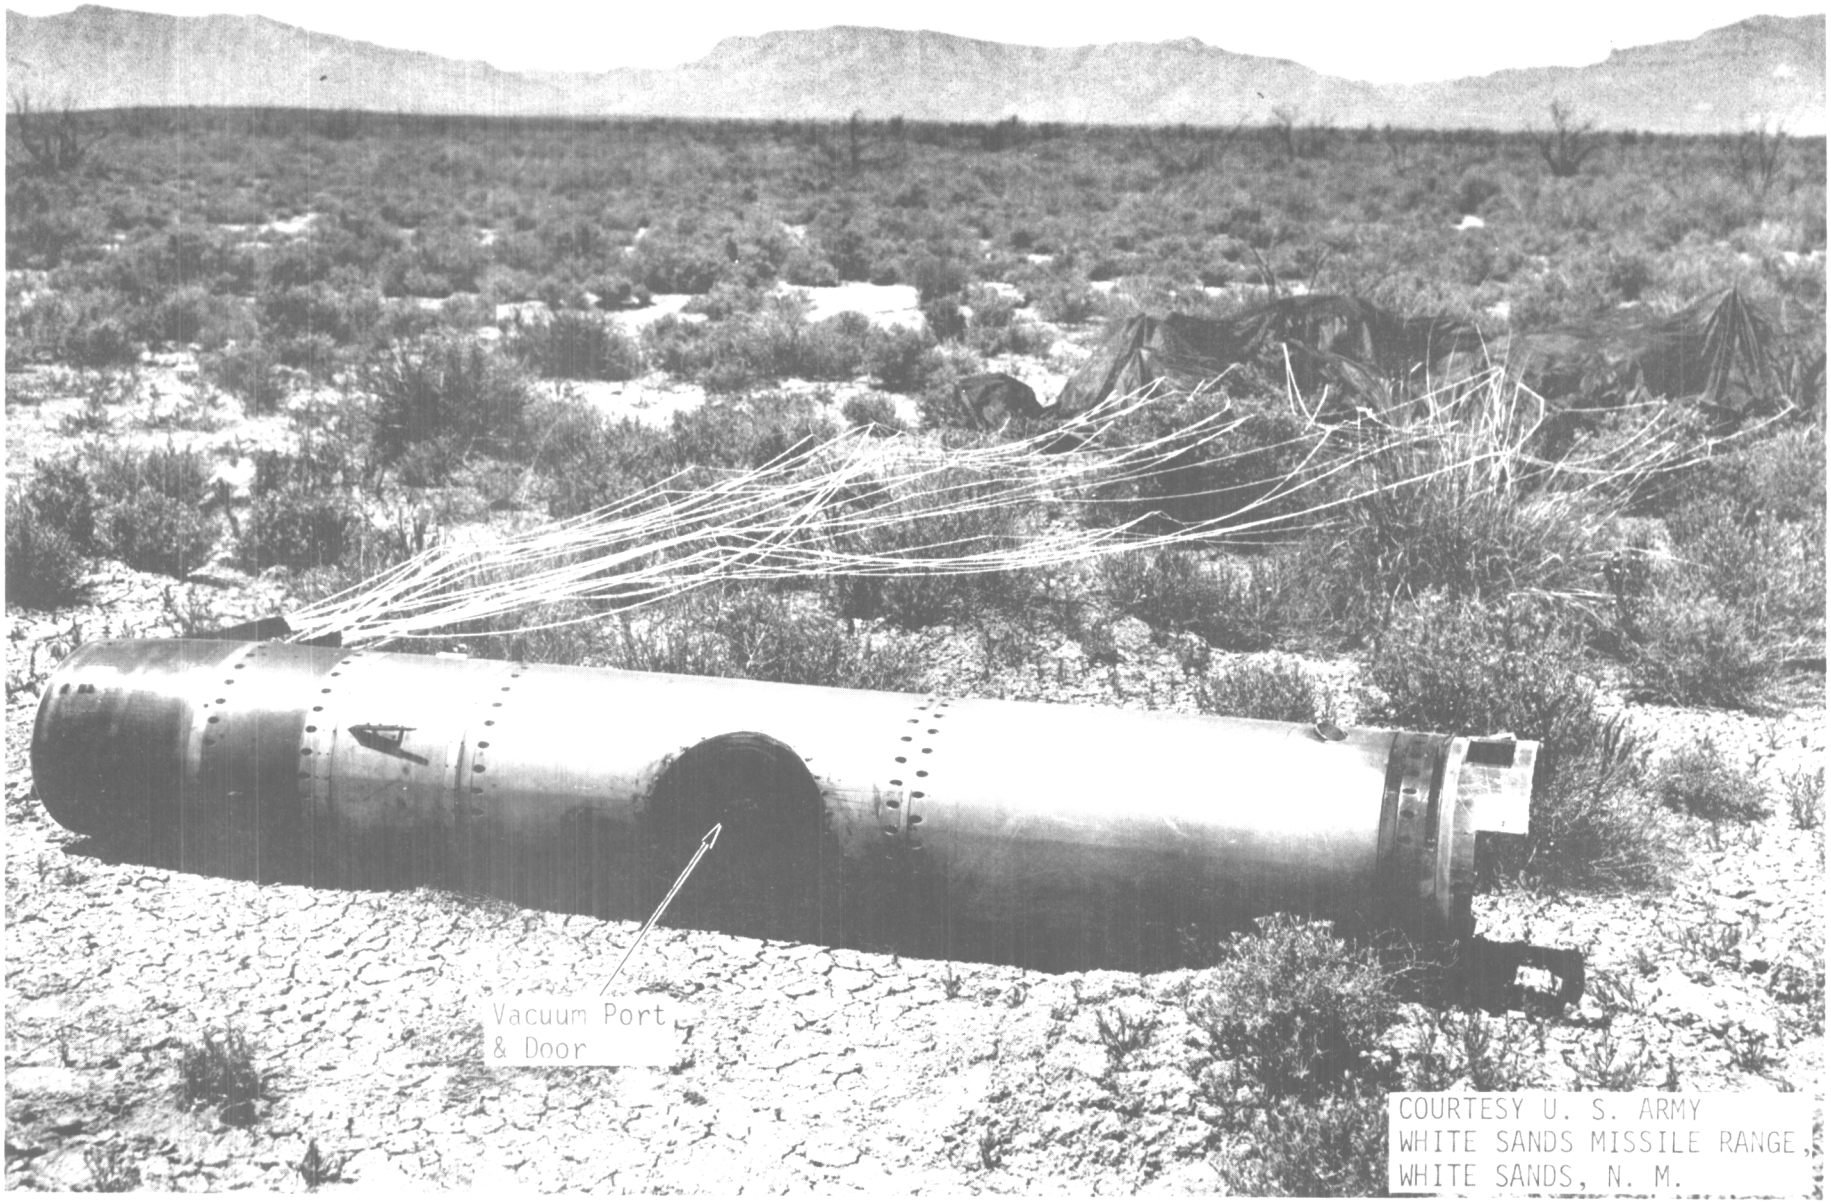
Figure 6-5. Post-Flight HCO CALROC 21.021 Payload.

Following Instrument turn-off, the drogue and main parachutes were deployed and successfully recovered the payload as shown in Figure 6-5. This payload was refurbished and later flown on flight 21.023.
